Simulation of cement removal on titanium surfaces

C. Trempler*, M. Behr and G. Handel

(Department of Prosthetic Dentistry, University Medical Center Regensburg, Germany)

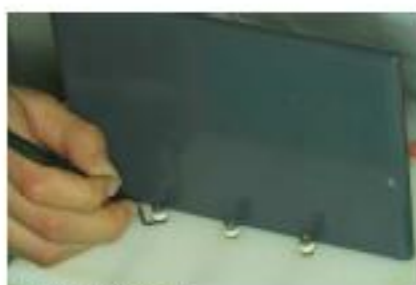
Fig. 2: Simulation of cement removal

The clinical procedure of cement removal was simulated using a model with titanium beams of 6mm diameter. Three investigators cleaned up 6 specimens which had a standardized layer of #1 zinc phosphate (Harvard, Hoffmann, Berlin, G), #2 glass ionomer (Ketac Cem, 3M ESPE, Seefeld, G), #3 resin cement (Calibra, Dentsply, Milford, USA), #4 self-adhesive composite cement (RelyX Unicem, 3M ESPE, Seefeld, G), or a #5 provisional eugenol-free cement (Provicol, Voco, Cuxhaven, G) using steel or plastic scalars. Each specimen was treated for 30sec under blinded standardized conditions. The cleaned surfaces were digitally recorded and cement remnants were evaluated using an image analysis program (Optimas Corporation 6). Statistical analysis: Mean, standard deviation, ANOVA.

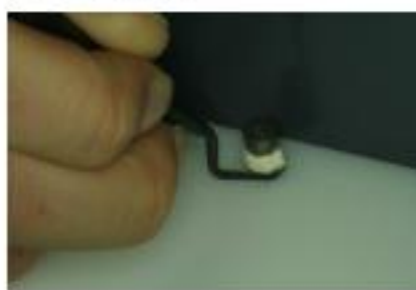
Fig. 5: Simulation of cement removal

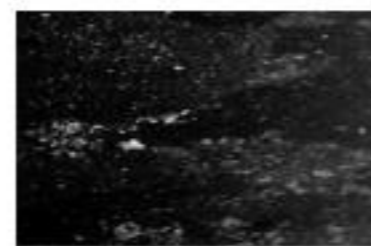
Fig. 6: Zinc phosphate cement (3 times magnification)

Surplus of cement was found on all specimens after cleaning. The amount of remnants depended on the investigated cement and scaler type. Glass ionomer cement processed with a steel scaler showed significant less remains ($p=0.05$). However, in some cases glass ionomer cleaning was quite difficult, which explains the high standard deviation. Self-adhesive composite and provisional cement showed significant higher amounts of cement remnants after the cleaning procedure ($p<0.001$)

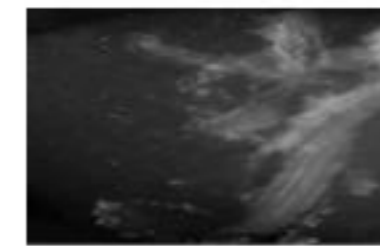
Fig. 8: Resin cement (3 times magnification)

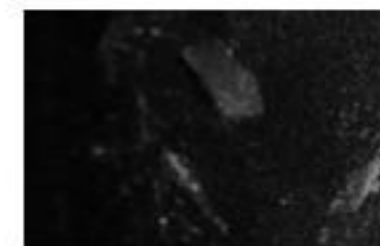
Fig. 9: Self-adhesive composite cement (3 times magnification)
